HOME INSPECTION REPORT

1501 Bryant Street, Somewhere, MN

5/23/2007

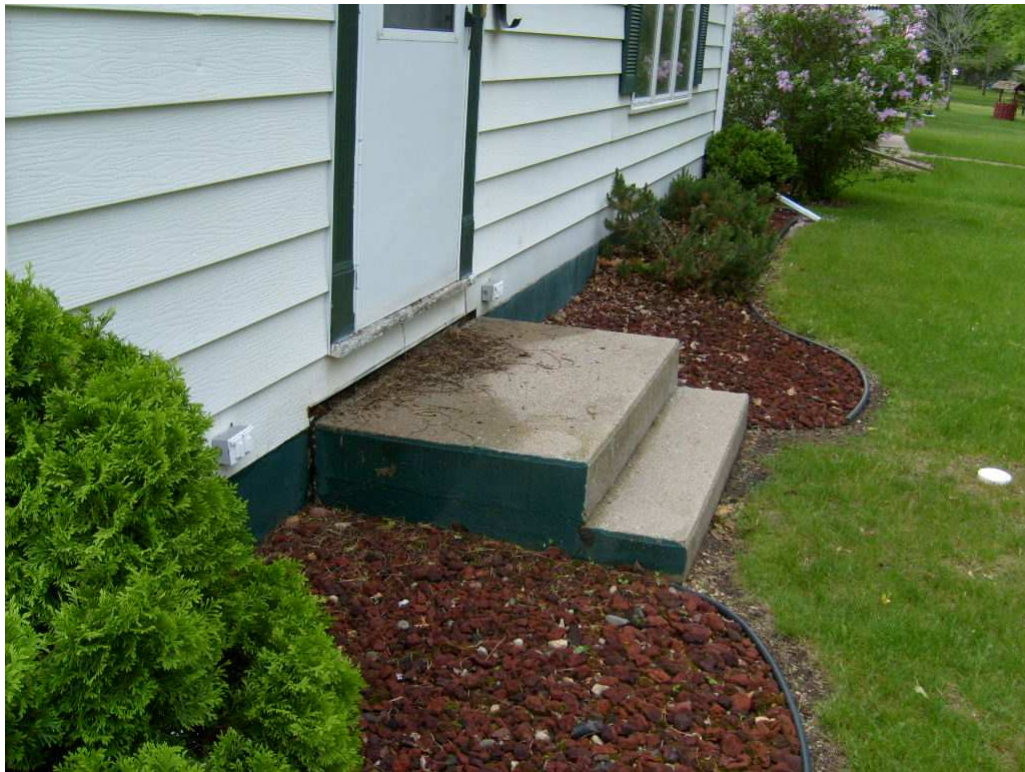
WALKWAYS: Walkway had some cracking, but is usable. **DRIVEWAY:** Driveway had some settlement, but usable, repair as needed. **DECK:** Deck appeared to be in satisfactory condition, seal as needed. **STOOPS/STEPS:** Stoop has settled, recommend mudjacking or replacing (see photo). **LANDSCAPING AFFECTING FOUNDATION:** Maintain a positive drainage slope away from the foundation. Low areas next to the foundation need some correction.

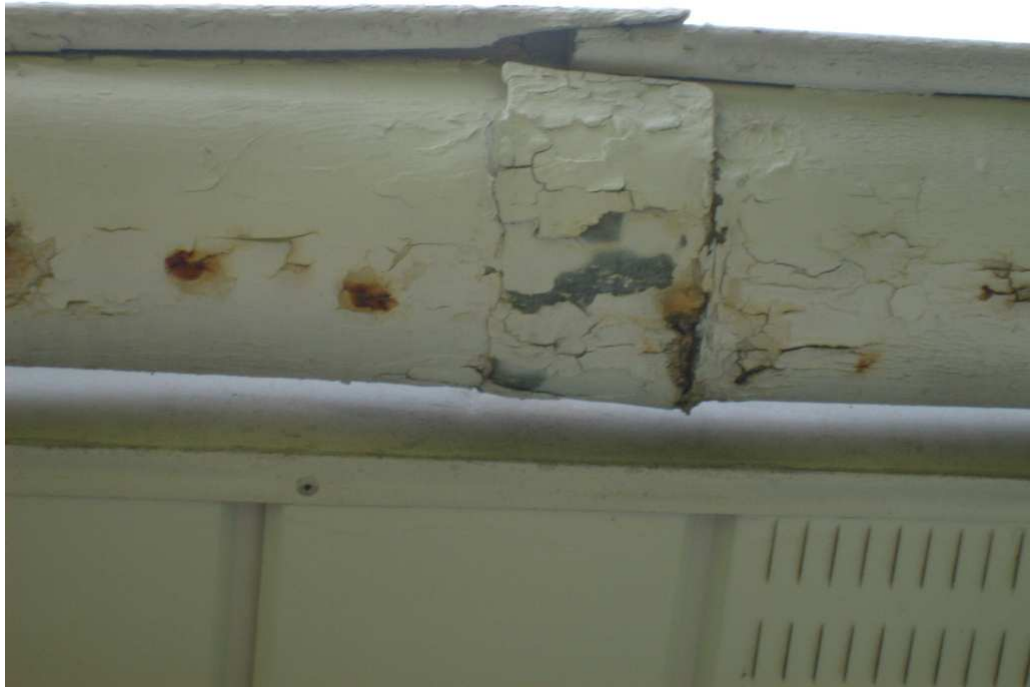
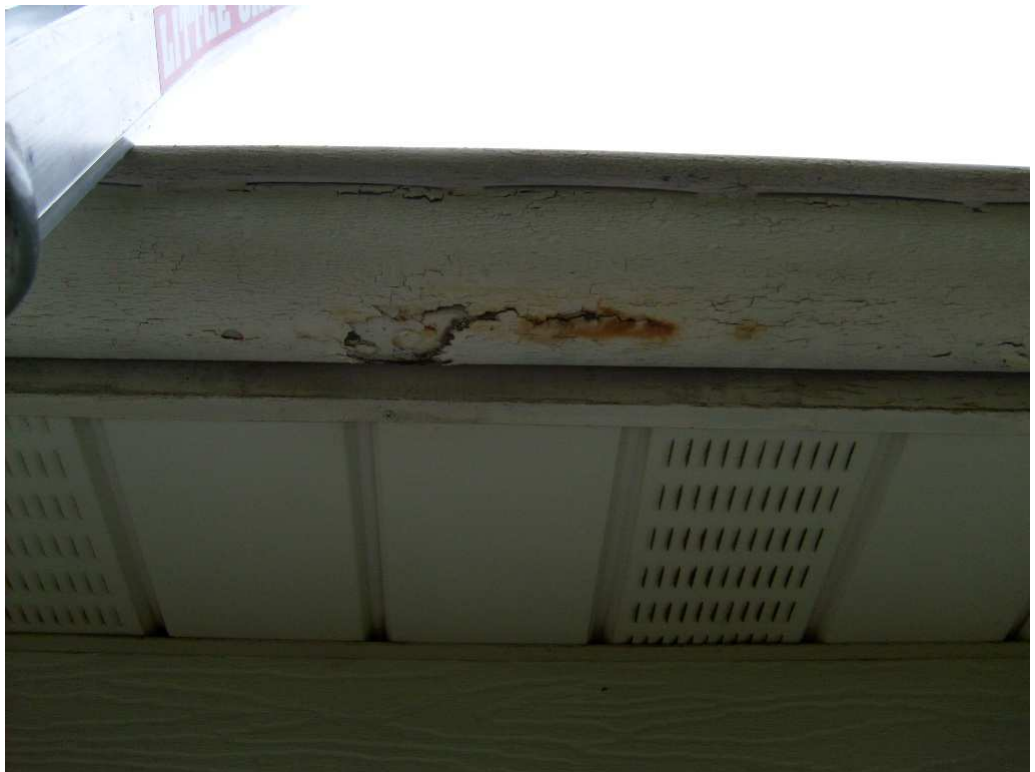
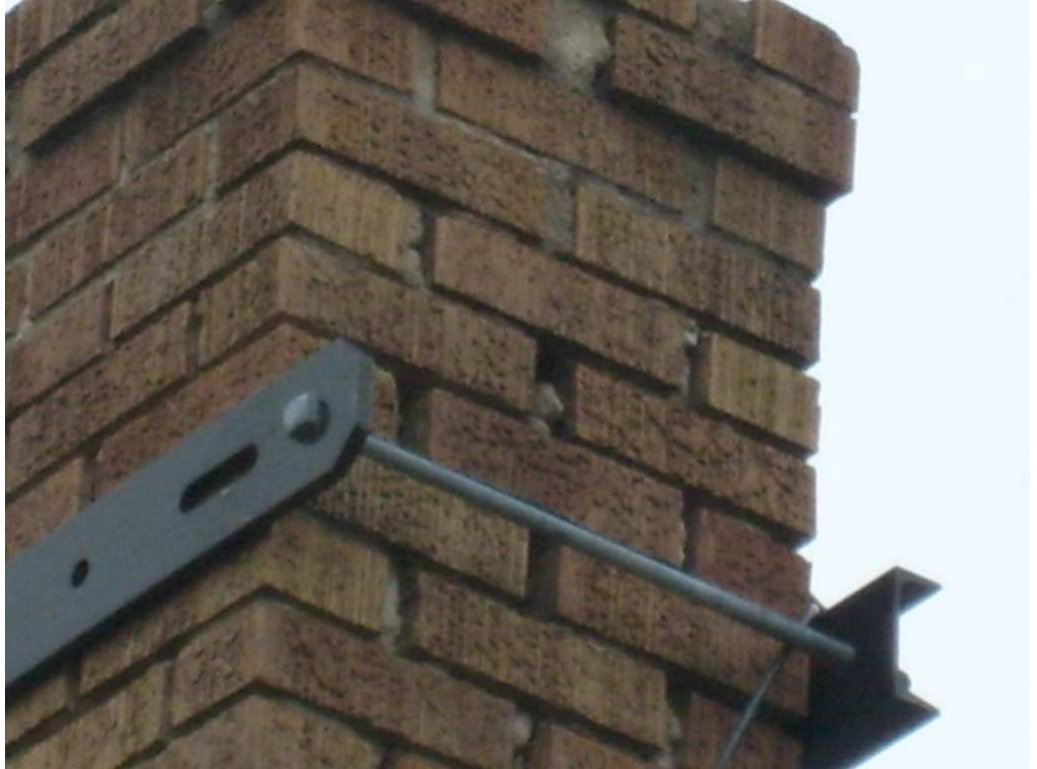
CHIMNEYS: Missing mortar in the brick joints - recommend tuckpointing as needed (see photo). Chimney flue was not evaluated. GUTTERS AND DOWNSPOUTS: Gutter(s) had some damage and were in need of repairs and /or replacement (see photo). Maintain downspout discharge away from the house. SIDING: Siding appeared to be all intact and in overall satisfactory condition. Normal caulking maintenance would be helpful. TRIM: Trim appeared to be intact and in overall maintained condition.

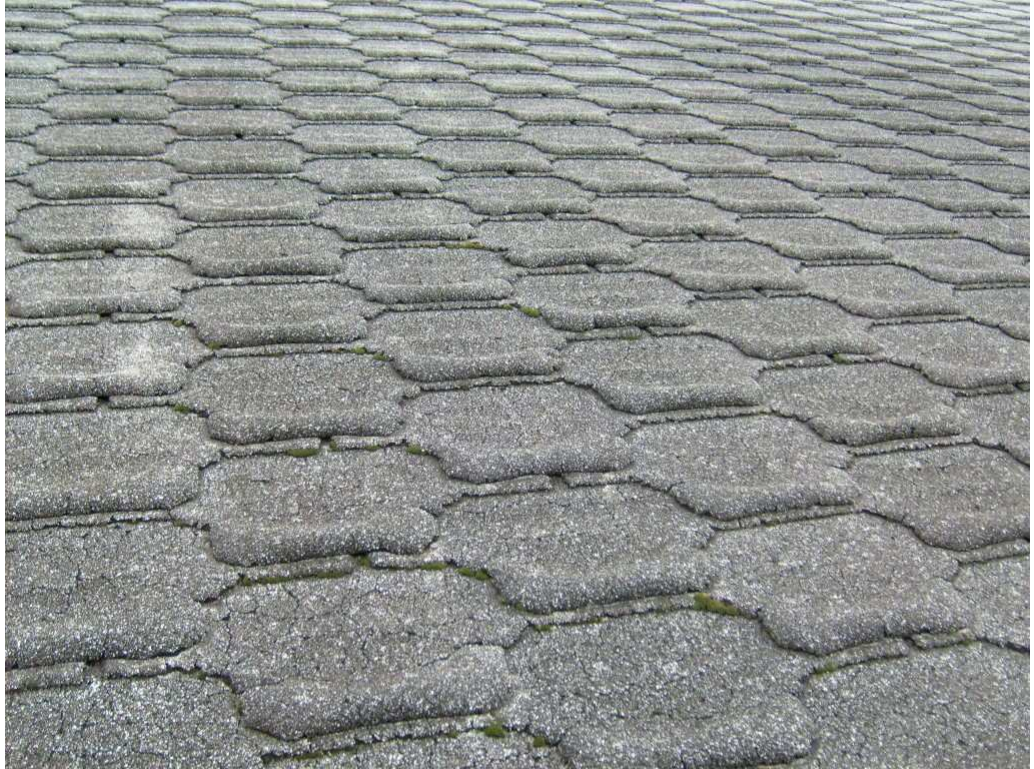
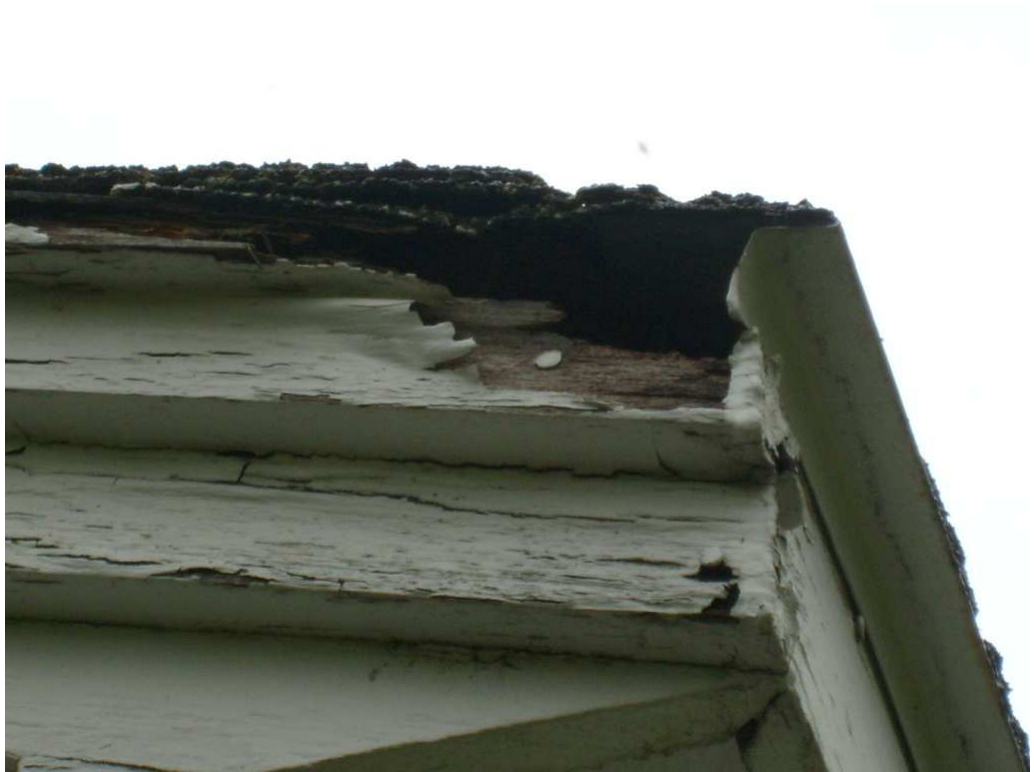
EXTERIOR DOORS: Doors were reviewed and found to be in working order. ELECTRICAL: Lights appeared to be in normal condition: not all lights were tested. GARAGE ROOF: Roof appeared to be nearing end of its useful life, budget to replace soon (see photo). GARAGE SIDING: Siding was in need of normal maintenance repairs. GARAGE TRIM: Trim had some damage and was in need of repairs (see photo). GARAGE FOUNDATION: The foundation had some cracking , but was in usable condition. GARAGE DOOR: Garage door and opener was in normal working order except for the electronic eyes on the west door were incorrectly installed – SAFETY CONCERN.

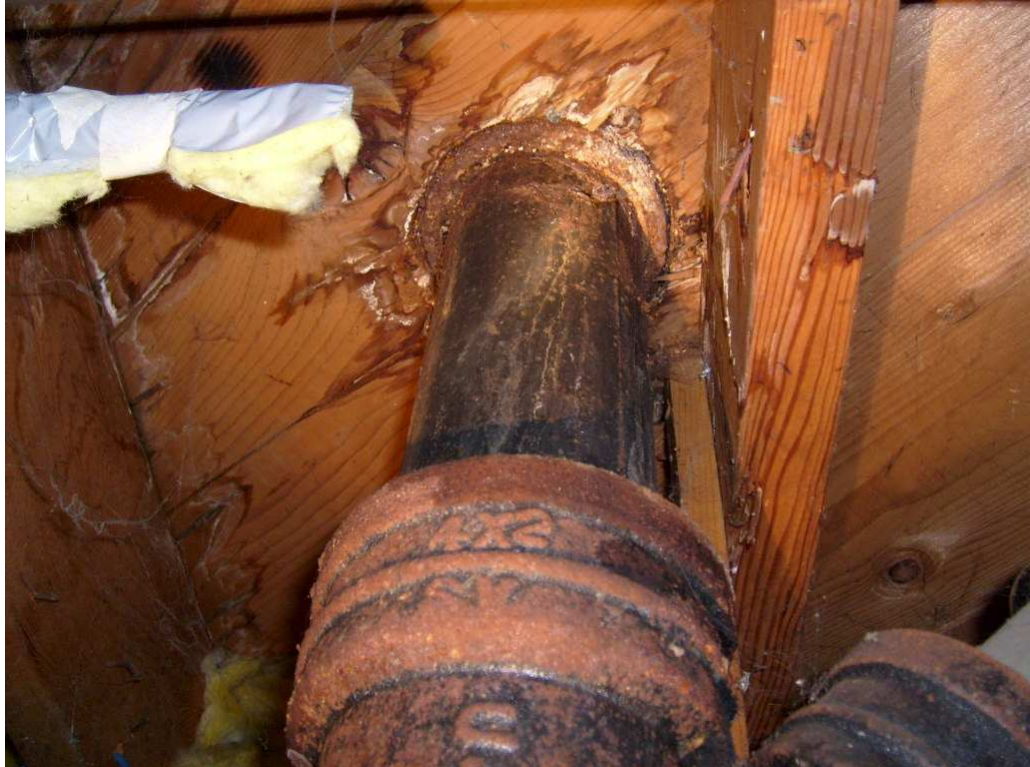
FOUNDATION: Foundation had some typical minor cracks, some had been patched. Recommend monitoring the cracks for future movement. Some foundation walls were covered with paneling/drywall and were not visible. FLOOR: Floor appeared to be in overall satisfactory condition. BASEMENT DRAINAGE/SUMP PUMP: No active seepage visible at the time of the inspection. Some old moisture stains are present, need to maintain proper slope away from the house and make sure the gutters drain properly. SUB FLOORING: Area around toilets have old moisture stains present – repair as needed (see photo).

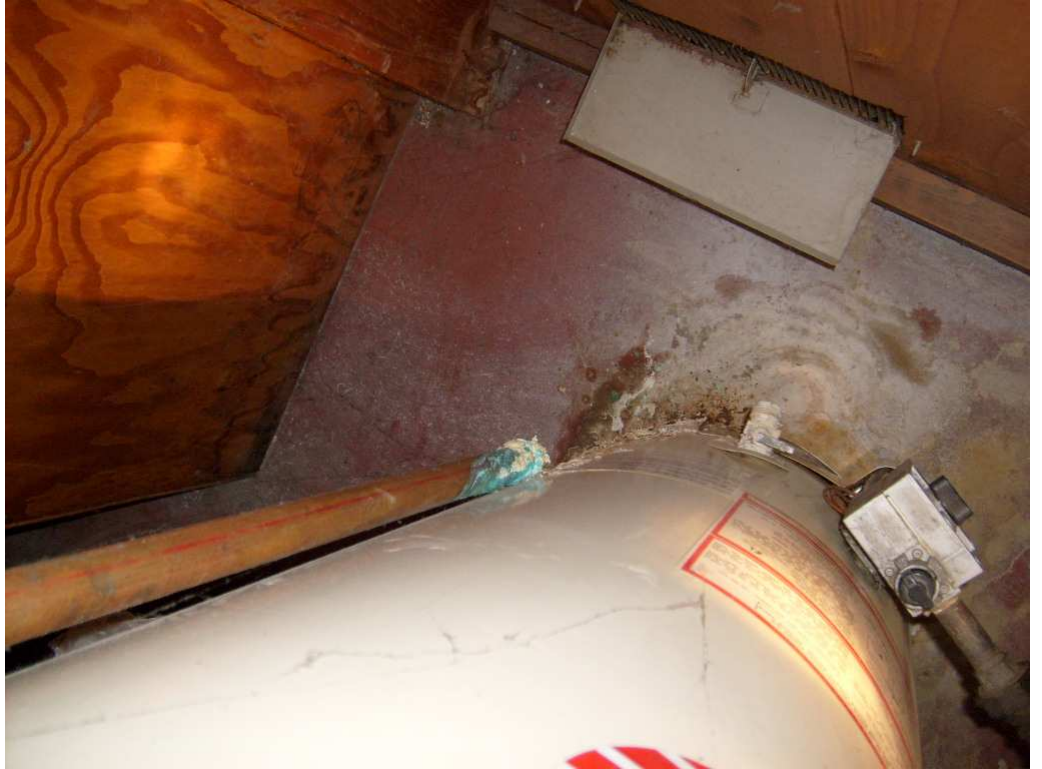
WATER HEATER: Excessive rust present at bottom on unit - recommend repairing and/or replacing as necessary (see photo). Temperature-Pressure relief valve extension needs to be 4"-6" off of the floor - this is a Safety Concern.

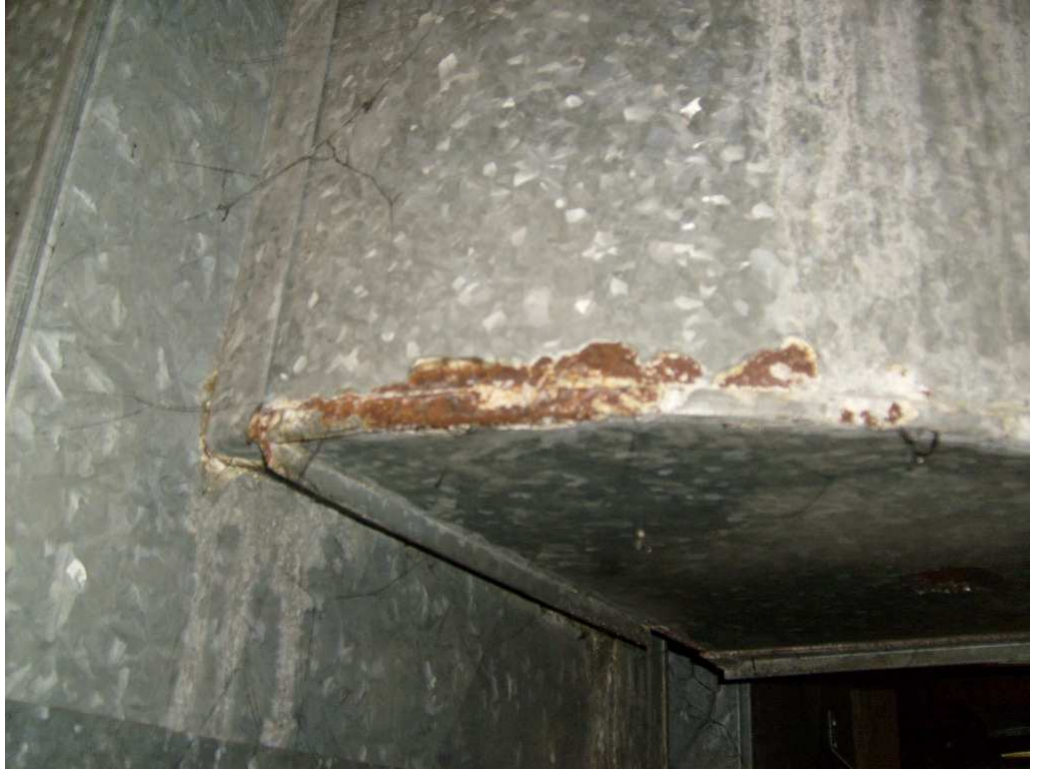
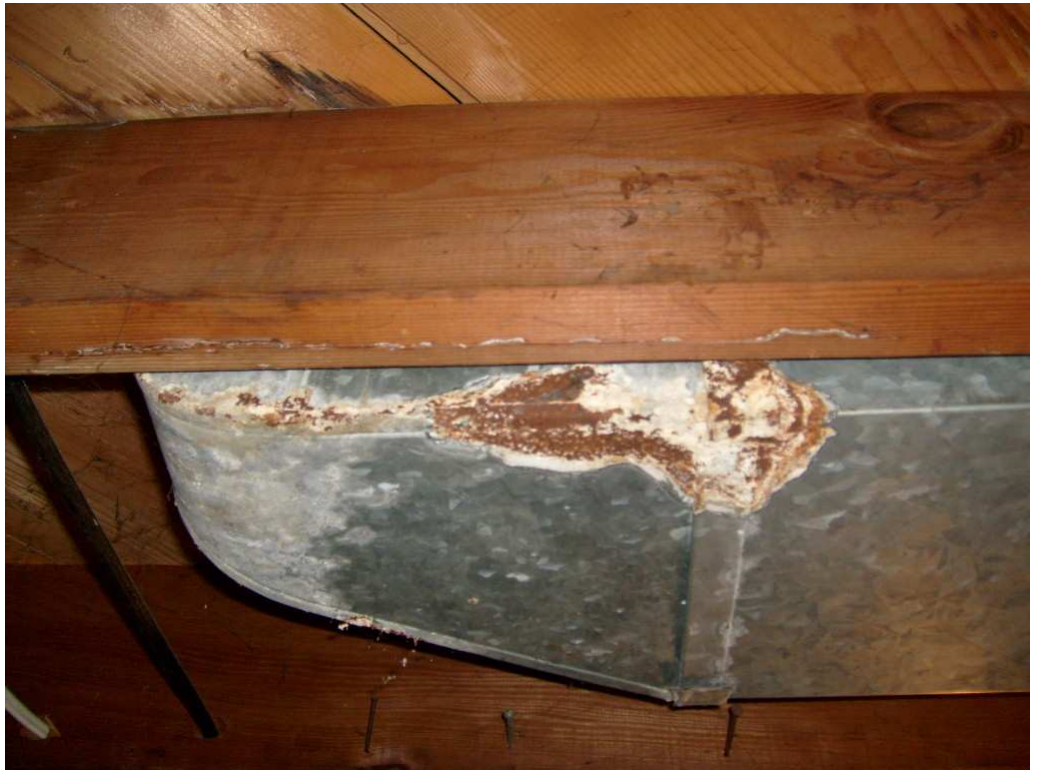
Others	<input type="checkbox"/> N/A <input type="checkbox"/> Electric baseboard <input type="checkbox"/> Radiant ceiling cable <input type="checkbox"/> Gas space heater <input type="checkbox"/> Woodburning stove (See Remarks page)
General Comments	<p style="color: red;">FURNACE: Furnace was in normal working order at the time of the inspection. FLUE: Flue was drafting properly at the time of the inspection. DUCTWORK: Recommend having ductwork cleaned. Some rust visible on supply ducts in the basement replace as needed (see photo). FILTER: Filter should be changed monthly.</p>
